Magnetic Heading Errors Trouble Shooting

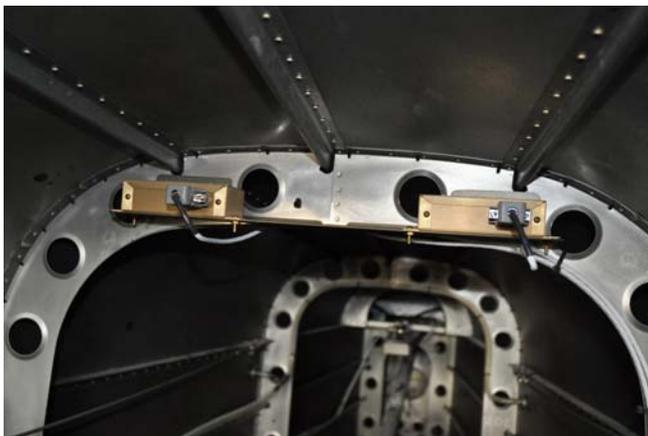
Magnetometer location in our RV-10 that has worked well.

The best place to mount the Magnetometer is in the wing or in the rear empennage.

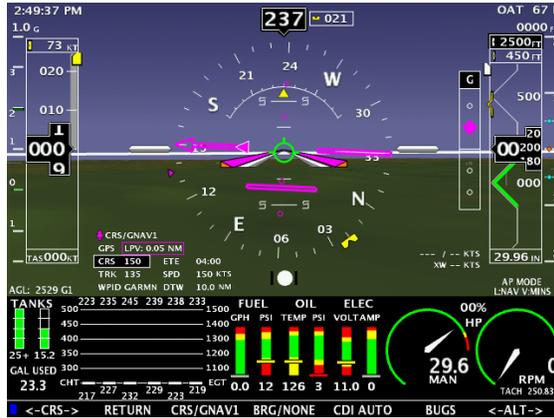
3. **Verify that the Magnetometer is communicating with the EFIS.** The 10 degree tick marks on EFIS DG will be white if the Magnetometer is communicating with the EFIS and **RED** if not. If the DG is red you need to double check your magnetometer wiring (verify that you have not reversed the plug wiring!).
